## Property Inspection Report

Listing Inspection

| <div>ADDRESS</div> <div>412 Maple Crest Lane, Oakhaven, CA</div> | <div>CLIENT</div> <div>Jordan Whitfield</div> |

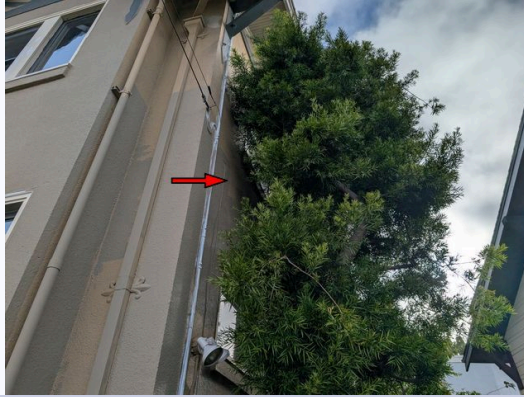
**Major****Plants are growing near or against the...**

Plants are growing near or against the exterior in several places and we recommend they be trimmed away from the building or removed to prevent damage and insect entry.

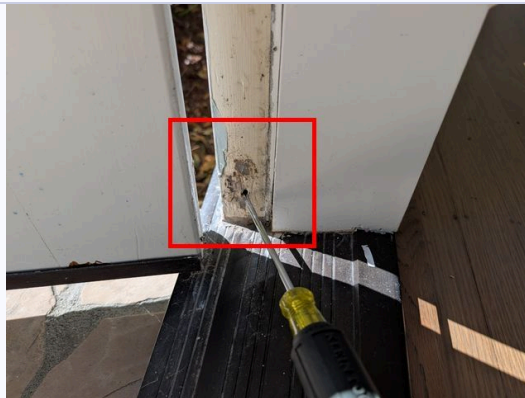
**Door Jambs at the \_\_\_ DAMAGED**

The French door at the dining room and the door jambs at that rear door are damaged by wood destroying organisms and we recommend repairs as needed.

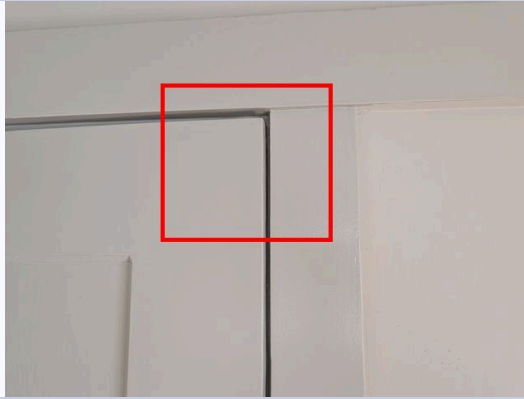
**Major****Door at The \_\_\_ RUBS FRAME**

The door at the right-rear bedroom rubs at the frame and we recommend it be repaired to operate freely.

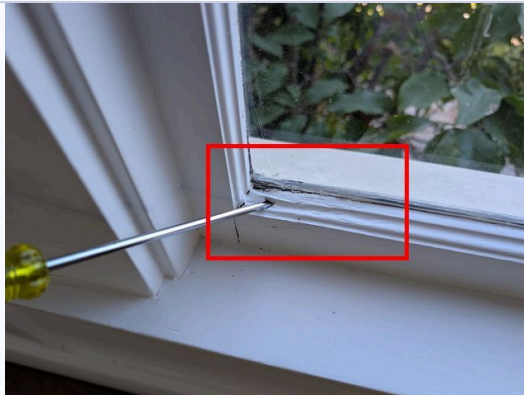
**Major****Several WINDOW SASHES Are DAMAGED**

Several window sashes (frames that hold the glass) are damaged.

We recommend the damaged sashes be repaired or replaced as needed.

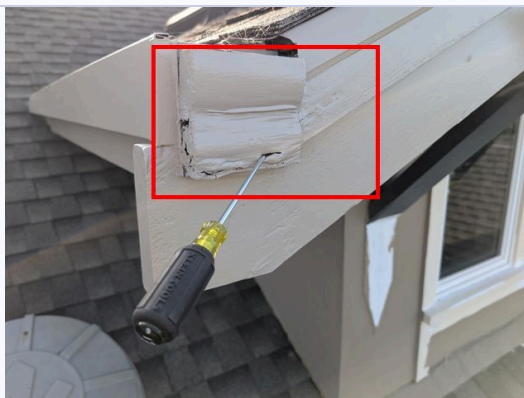
**Major****Wooden Fascia Boards DAMAGED ISP**

The wooden fascia boards at the roof perimeters are damaged in several places and we recommend repair or replacement as needed.

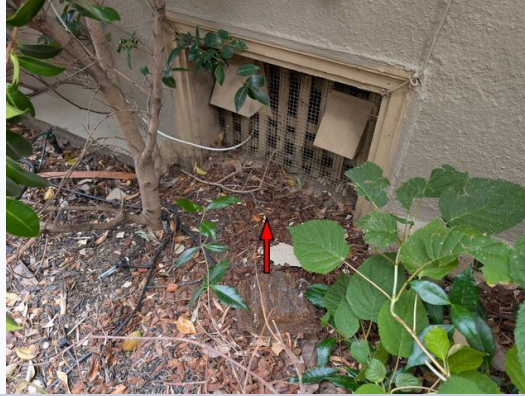
**Major****We observed faulty grade conditions at the...**

We observed faulty grade conditions at the right. We recommend a licensed structural pest control firm be consulted to evaluate the building and we recommend the foundation or soil level be modified as needed to provide proper grading and soil slope.

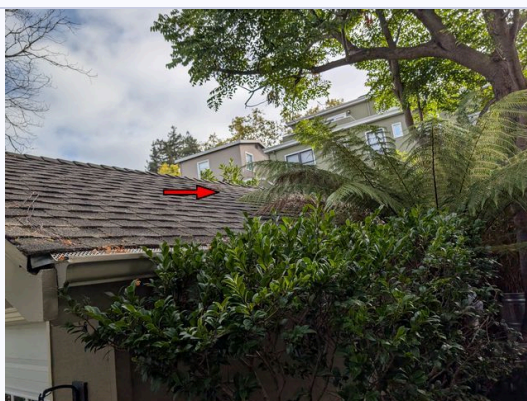
**Minor****Trim Trees and/or Plants over Roof**

Trees and/or plants are growing over or near the garage roof we recommend they be trimmed well away from the roof surfaces to prevent debris accumulation and roof surface damage.

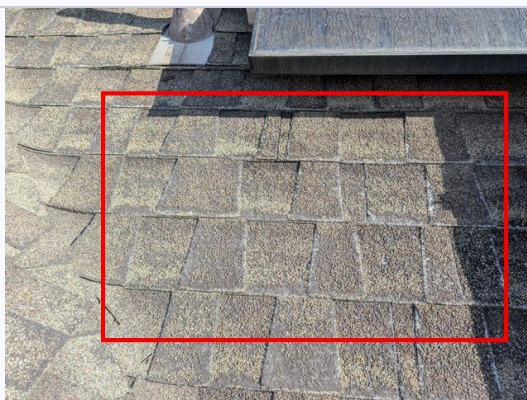
**Bald Spots (Walk On a Roof)**

Some of the shingles near the solar panels have "bald spots" with minor granule loss, the type that can often happen when people walk on a roof in hot weather. The areas without granule protection are more likely to leak prematurely. We recommend having these areas checked in the course of routine roof maintenance.

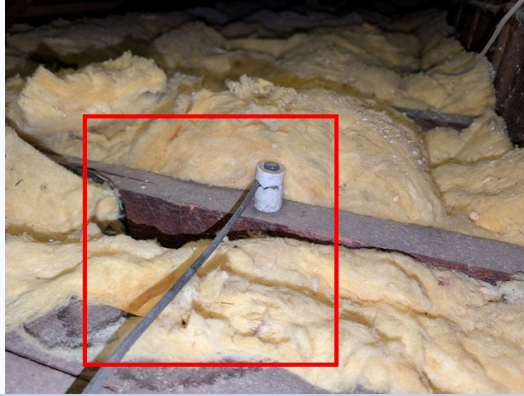
**Critical****Insulation over Active KandT (No Certificate)**

The insulation has been installed over knob and tube electrical wiring, but an electrician's certificate is not posted. We recommend the insulation be removed until the wiring can be certified as safe or replaced with updated wiring by a licensed electrician.

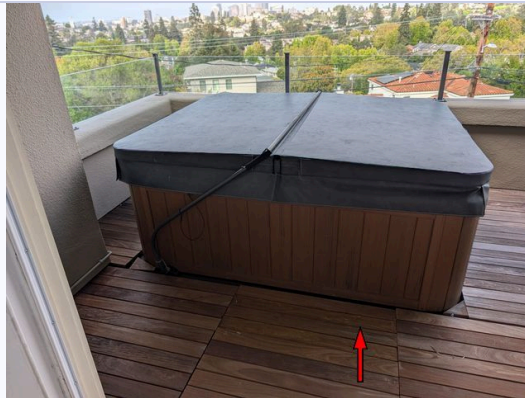
**Major****Per documentation provided by the realtor, a...**

Per documentation provided by the realtor, a permitted reconstruction of the roof deck was completed in 2013. Review of the documentation and the adequacy of the design to support the hot tub/spa is beyond the scope of this inspection. If further information on the work performed is desired, we recommend review by a licensed contractor or structural engineer.

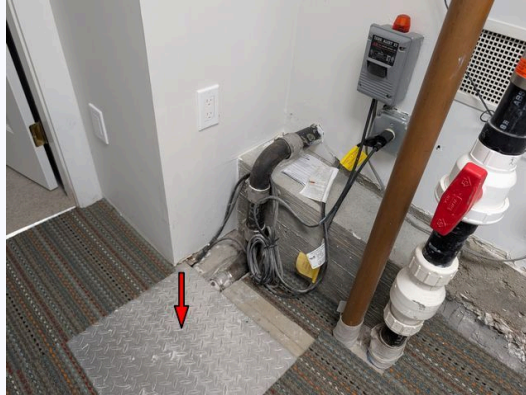
**Minor****Not Tested**

There is a sump pump at the front of the basement. The sump pump and well appear properly installed. We did not test the sump pump, which should be tested periodically by filling the sump or well with water to see if it functions properly.

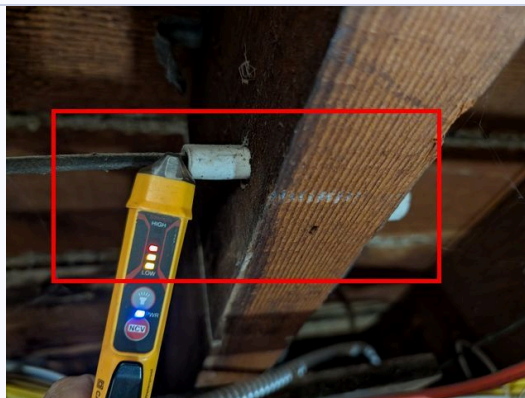
**Critical****This building has some live knob and...**

This building has some live knob and tube wiring. We did not see any improper modifications made to the knob and tube wiring that would make it hazardous. However, it should be noted that many insurance companies are not insuring homes with knob and tube wiring.

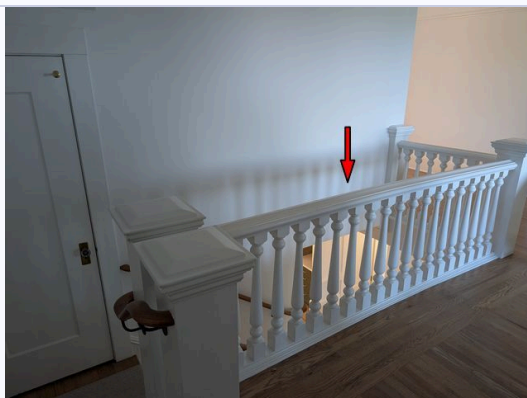
The upper-level guardrail is too low by modern safety standards, which require guardrail's to be at least 42 inches high.

We recommend the guardrail height be raised for greater safety.

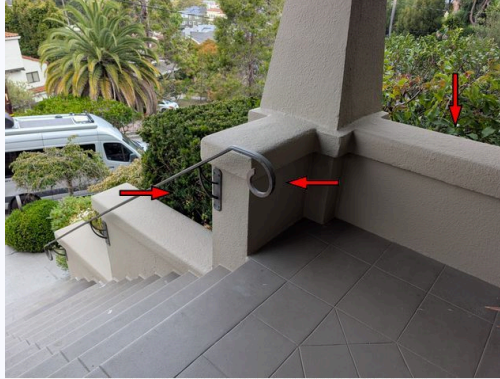
**Critical****Sev Guardrails Too Low**

The front porch guardrails are too low by modern standards, which require guardrails to be at least 42 inches high. The height of the guardrail could be raised, or new railings of the proper height could be installed to minimize the fall potential.

Low guardrail, large openings, and non-returning handrail

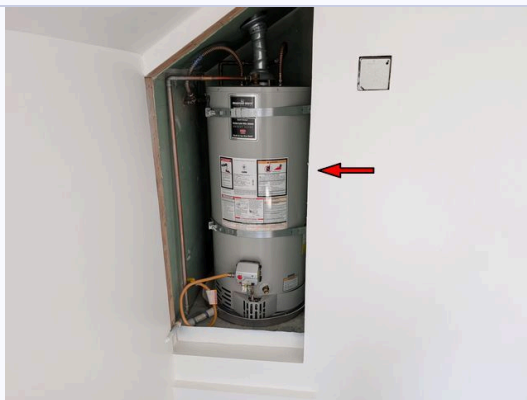
There is a 40-gallon, gas-fired water heater in an attic closet that appears to serve the finished attic bathroom. The water heater was manufactured in 2017 with an expected service life of 10 years.

The water heater shows moderate wear and is in the late-middle of its expected service life. With routine maintenance, it should last for several more years.

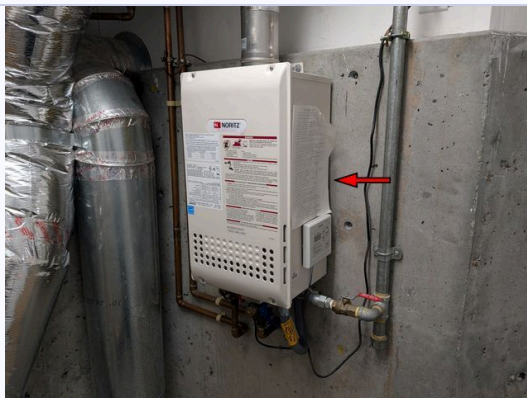
There is a non-storage, on-demand-type water heater located in the basement. The water heater was manufactured in 2011 with an expected service life of 20 years. This water heater is in the late-middle of its expected service life. With routine maintenance, it should last for several more years.
